# St Bartholomew's Church, Hyde, Winchester

## Historical graffiti survey report

Date of survey: **17<sup>th</sup> October 2025**

**Hampshire Medieval Graffiti Project**

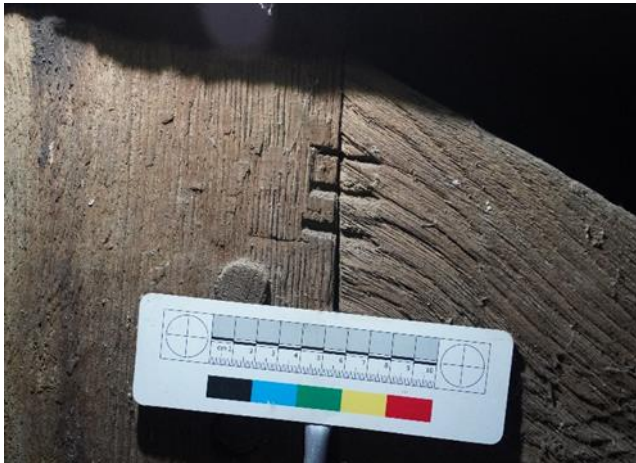
The numbers ran in sequence. A good example of this can be seen on the roof timbers of the bell chamber, where there are joints numbered with 3, 2 and 1 lines on the north/south beams running from west to east (Figs 3 - 5). See Plan B

*Fig 3. Tower. Bell chamber. Joint marked III*

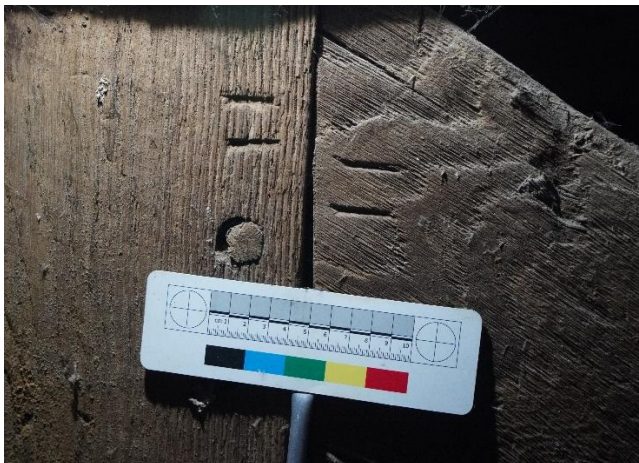
*Fig 4. Tower. Bell chamber. Joint marked II*

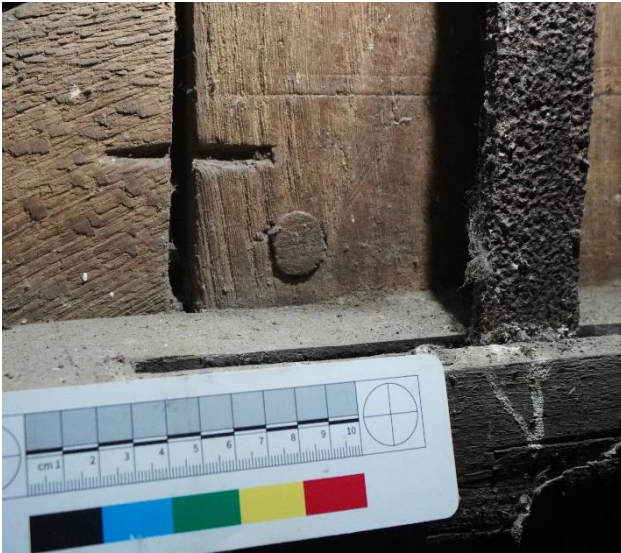
*Fig 5. Tower. Bell chamber. Joint marked I*

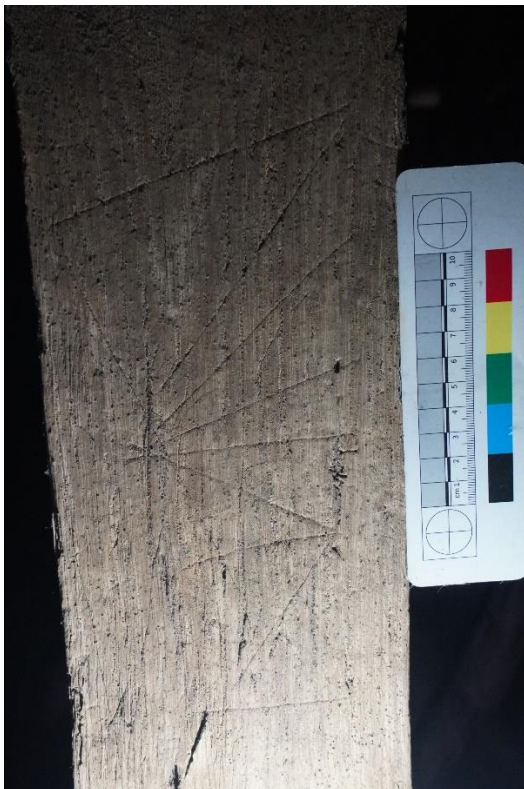
Geometric shapes, like arrows, were also found on timbers on the 2<sup>nd</sup> and 3<sup>rd</sup> floors (Fig 6). These are not next to joints but were probably also made as marks to aid construction.

*Fig 6. Tower. Bell chamber. Bay 1. Carpenter's marks*

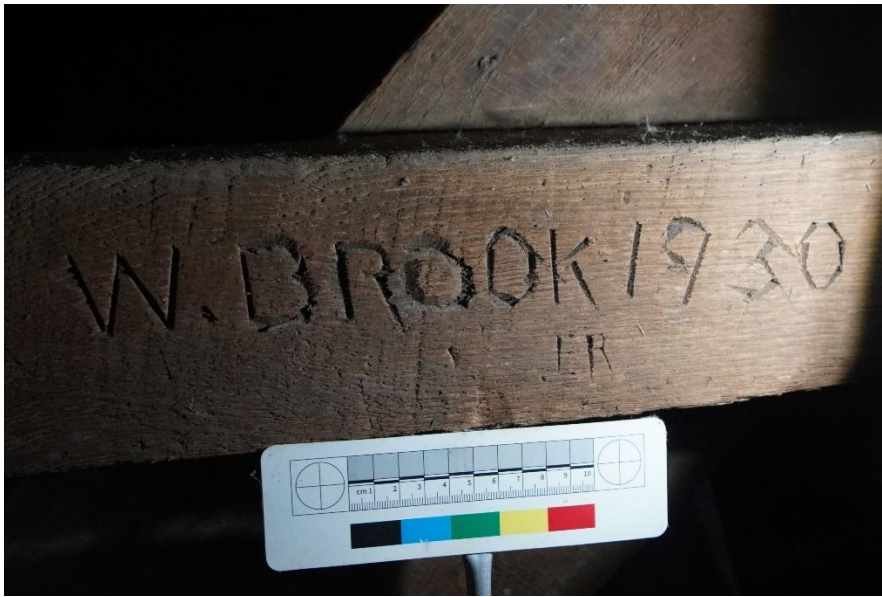
tower at this time. In the bell chamber are two, both dated 1930, made by W. Brook (Fig 7) and E. Rickman (Fig 8).

*Fig 7. Tower. Bell chamber. W. Brook 1930*

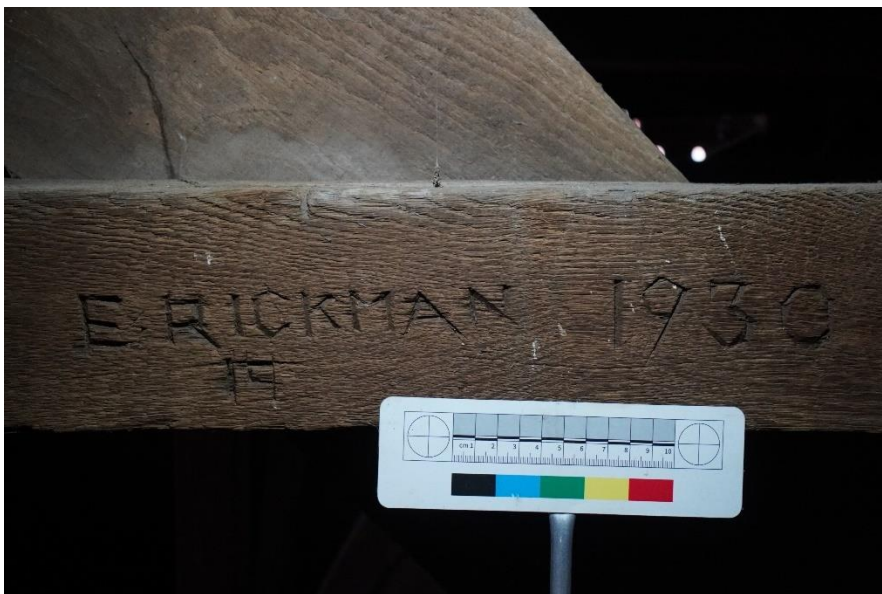
*Fig 8. Tower. bell chamber. E. Rickman 1930*

Initial searching of local trade directories for 1930 has failed to identify these names with certainty. There are also the pairs of initials DW and JH, which were left on a beam in 1942.

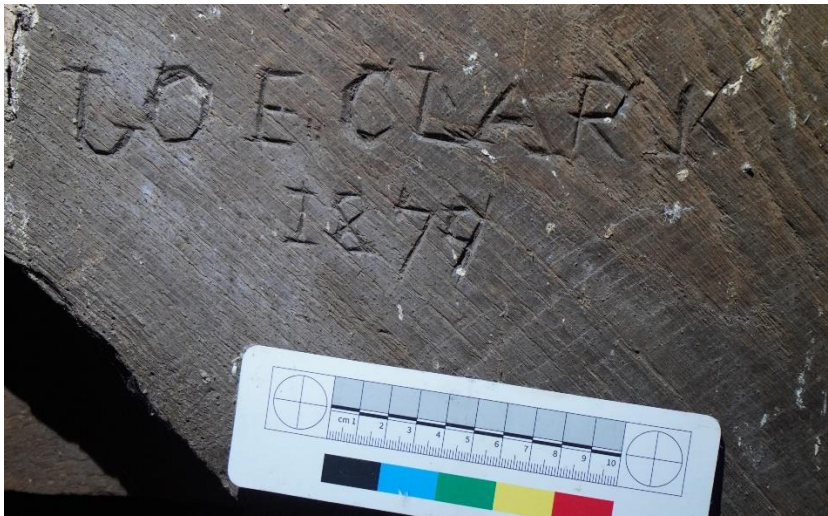
There is an earlier inscription, made by Joe Clark in 1879 (Fig 9). Joe has written the J back-to-front, suggesting he was not so confident at writing. We know there were repair works going on in the church in 1879 so it is likely that Joe was involved with these. There are two references to members of the Clark family in the 1880 Masters Winchester Trade Directory: Job Clark, the householder at 79 Hyde Street, and

Joseph Clark, at 39 Hyde Street. It seems likely that Joe was associated with one of these families, bearing in mind their proximity to the church.

Fig 9. Tower. Bell chamber. Joe Clark 1879

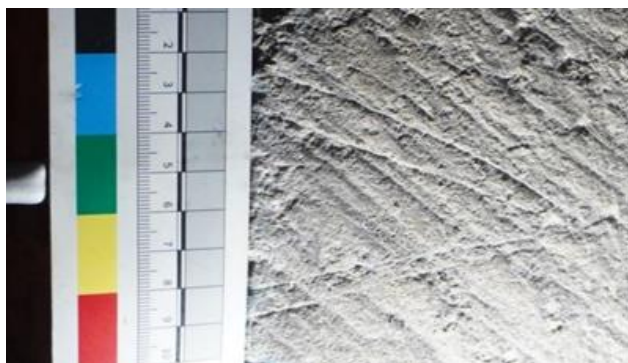
Fig 10. Tower. Second floor. South window jamb. V shape, possibly apotropaic

Other people left their marks on the stonework in the tower. These were mainly as initials, names and dates, although there is a V-shaped mark on the east jamb of the south window on the second floor (Fig 10). This could be a mason's mark, but as no other masons' marks were found this is less likely, so it could be an apotropaic mark.

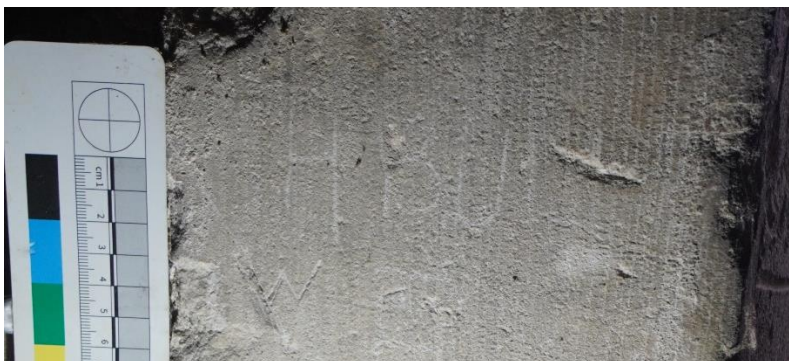
There are many initials and one full name, H. Bull, around the south window on the second floor (Fig 11), with dates from the 17<sup>th</sup> to 20<sup>th</sup> centuries.

Fig 11. Tower. Second floor, south window. H Bull

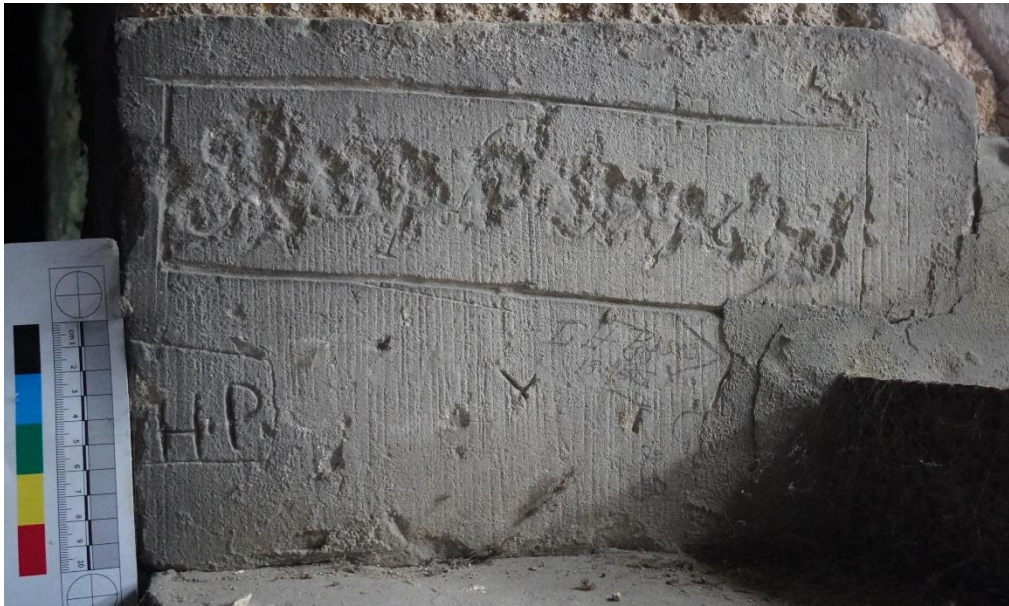
Some initials are carved within boxes, for example HP (Fig 12). Above this is a large rectangular shape or cartouche containing writing, probably a name, which has been vigorously hacked out, although the date 1690 is still visible. That someone wished to obliterate this name suggests bad feeling directed towards an individual who has perhaps misbehaved or offended in some way.

*Fig 12. Tower. second floor. HP and hacked out inscription, probably a name*

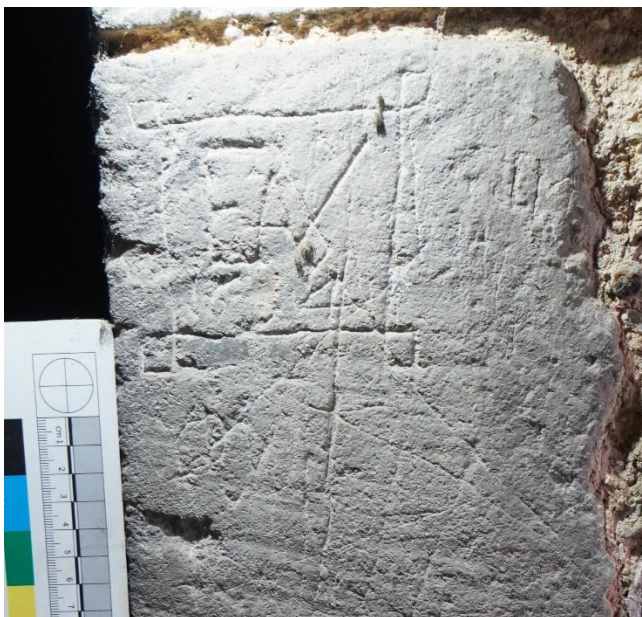
*Fig 13. Tower. Second floor. EA in frame*

In the same area the initials EA occur within an elaborate frame, with looped corners (Fig 13). There are later shapes and lines overlying it, making it hard to read.

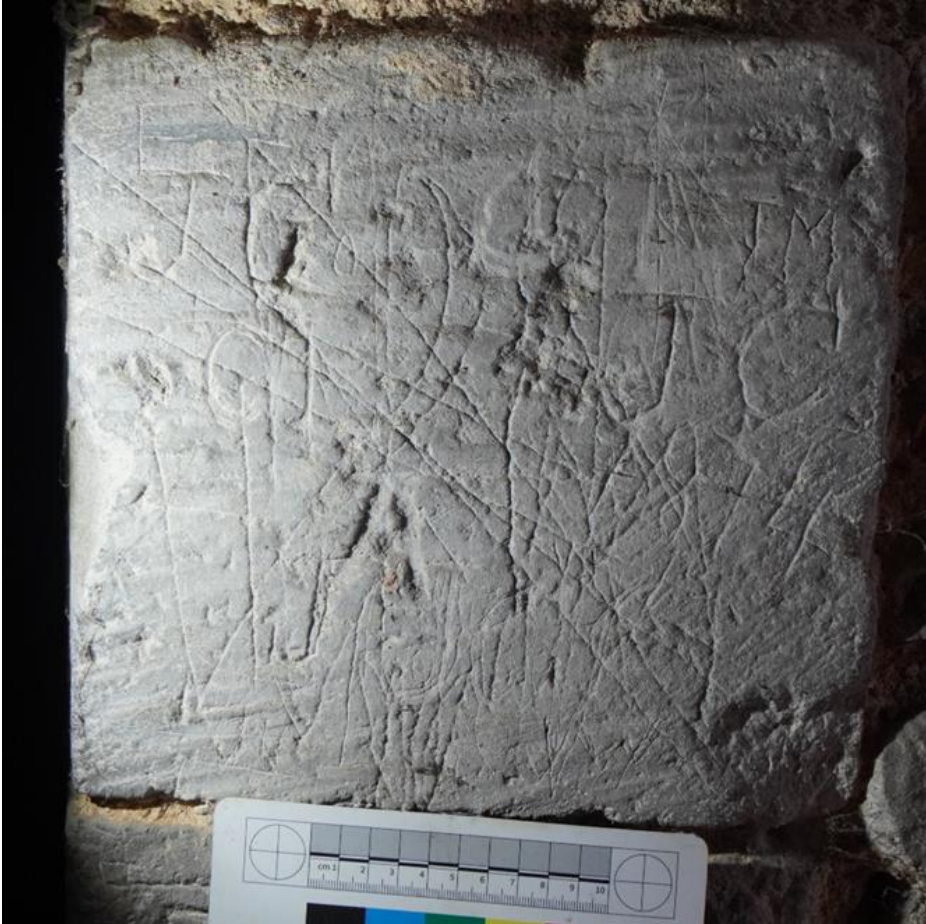
Above this is another block with many shapes and initials scratched onto it, and the date 1874 (Fig 14). We can only guess at the identity of the makers of these marks, but they could be bell ringers, workmen, or visitors with some other business in the tower.

*Fig 14. Tower. Second floor. Initials and date 1874*

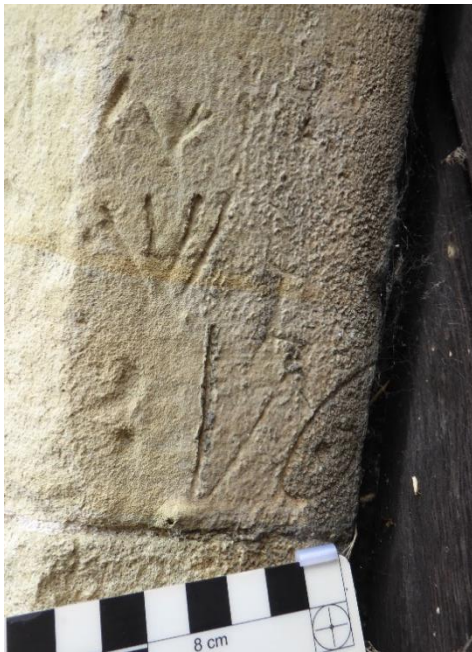
The west doorway of the tower (Fig 15) has graffiti on both sides of the arch. There are matching dates at roughly the same height on each side. That on the north side is incomplete with only 176 remaining (Fig 16), but the full date 1763 can be seen opposite, associated with the initials IE (Fig 17). Above the date on the north side is a shape which might be an initial W, or it might be a VV symbol, of interlocking Vs. Such marks are apotropaic in function and derive from the Christian symbol of devotion to the Virgin Mary, the VV standing for *Virgo Virginum*, or Virgin of the Virgins. Post-Reformation, this symbol seems to have lost its religious connotations and became more of a lucky symbol. It is often found around windows and doorways of buildings, to prevent the ingress of evil spirits. A similar VV shape, now very faint, can be seen above the 1763 date on the south side. Below the date is a wavy line whose significance is unknown. There was probably a lot more graffiti in this area but

*Fig 16. Tower. West doorway. North jamb. Partial date 176 with VV above*

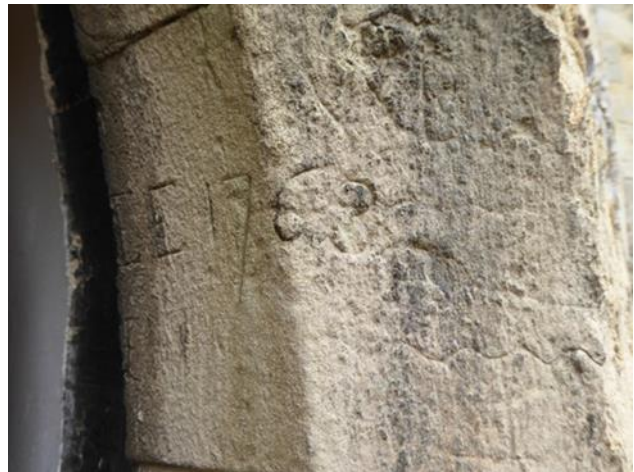
*Fig 17. Tower. West doorway. South jamb. IE 1763. VV above*

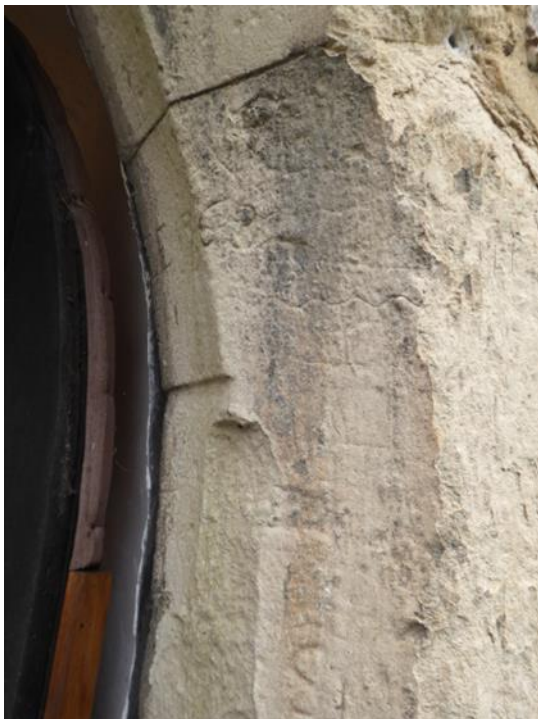
the stone surface is very weathered and much detail has been lost. An initial S can be seen further down, along with other fainter lines and initials (Fig 18).

*Fig 18. Tower, West doorway. South jamb. Initial S*

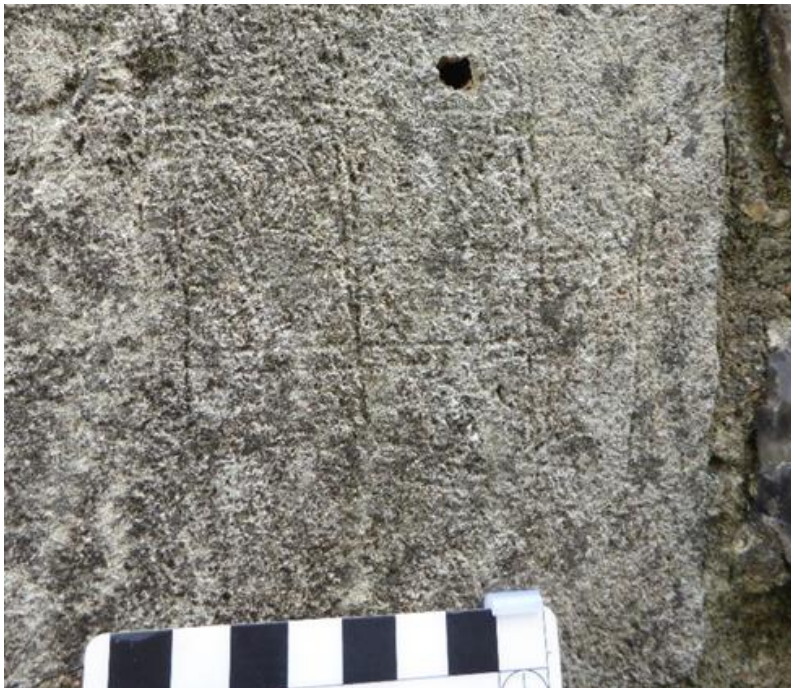
On the northwest buttress of the tower is scratched a 3x3 grid pattern (Fig 19). These grid or net patterns are found in both religious and domestic buildings, and are thought to

have had an apotropaic or protective function, made to entrap or ward off evil spirits. On the northwest buttress of the tower is a scratched 3x3 grid pattern.

*Fig 19. Tower. Northwest buttress. Grid pattern*

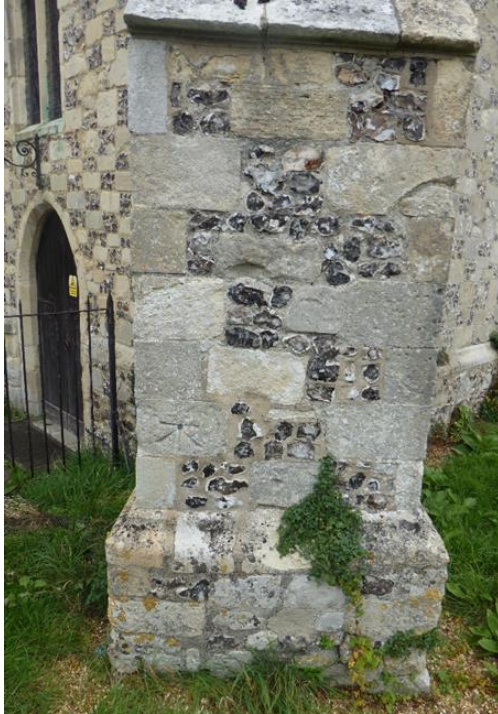
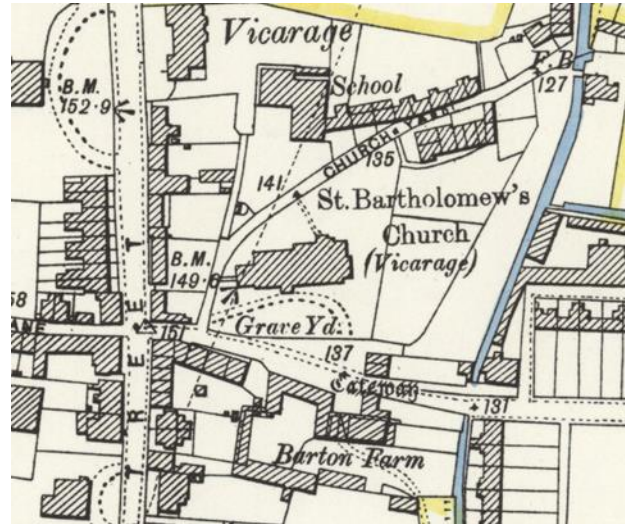
There is an Ordnance Survey benchmark on the southwest buttress of the tower (Fig 20). It cannot be dated precisely but it is shown on the 1897 6" Ordnance Survey map as B.M.149.6 (Fig 21).

*Figs 20 & 21. Tower. Southwest buttress. Ordnance Survey benchmark with location marked on 1897 map*

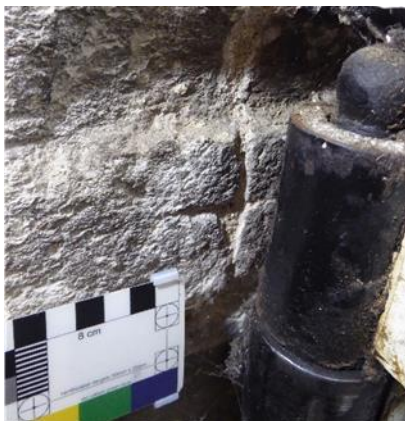
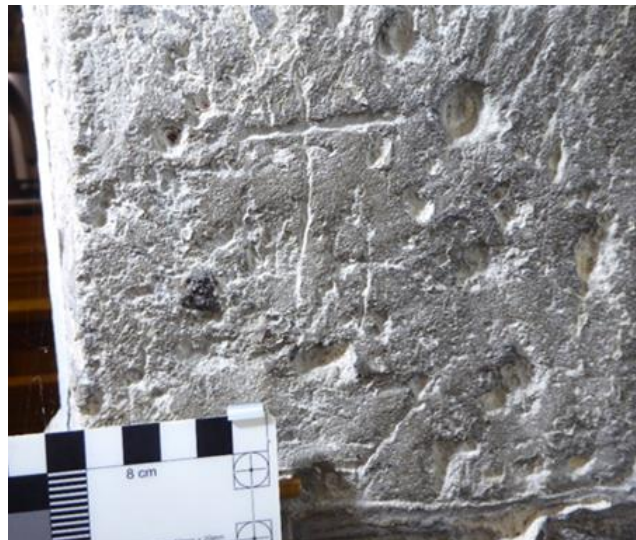
Figs 23 & 24. South doorway. East jamb.  
Crosses

The south doorway in the nave (Fig 22) has small crosses incised into the archway on the east side (Figs 23 & 24). Such crosses were probably made as a symbol of

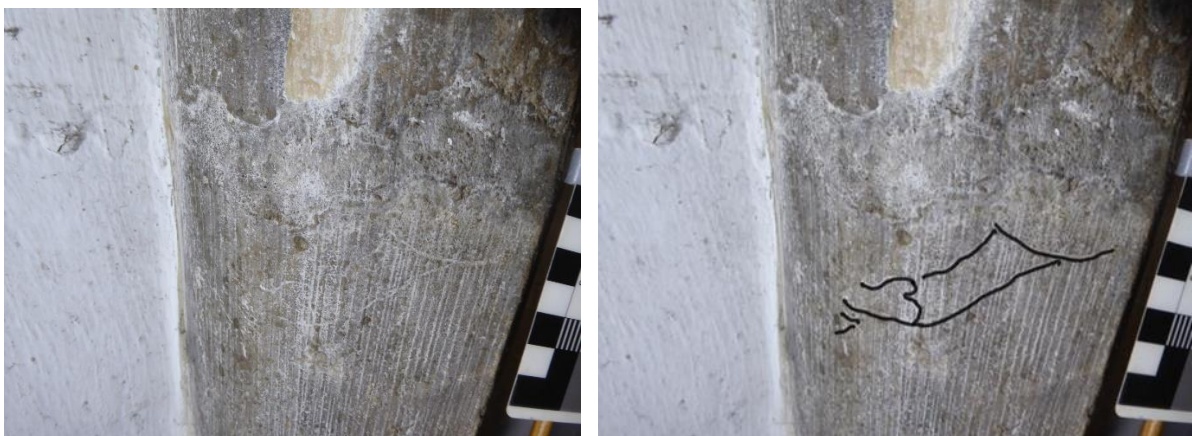
On its east face are incised some faint lines which appear to have been made deliberately and may be figurative (Fig 26).

*Fig 26. South nave. Pilaster. Possible depiction of arm protruding from sleeve*

They could resemble the depiction of an arm protruding from a sleeve, with linked hands, reminiscent of Tudor portraits which often show sitters in this pose with similar sleeves.

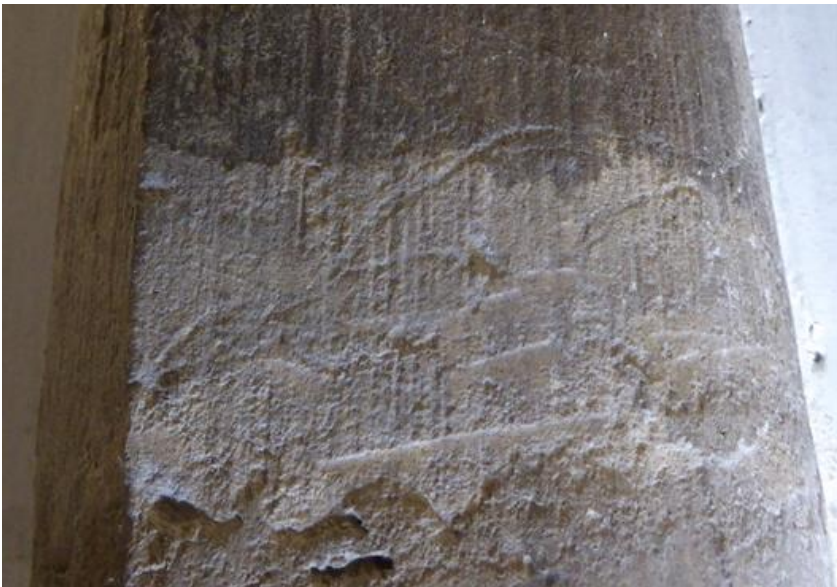
On the west face of the pilaster, higher up, are more curved lines which seem to have been carved deliberately (Fig 27). These may have been decorative or figurative.

*Fig 27. South nave. Pilaster. Curved lines*

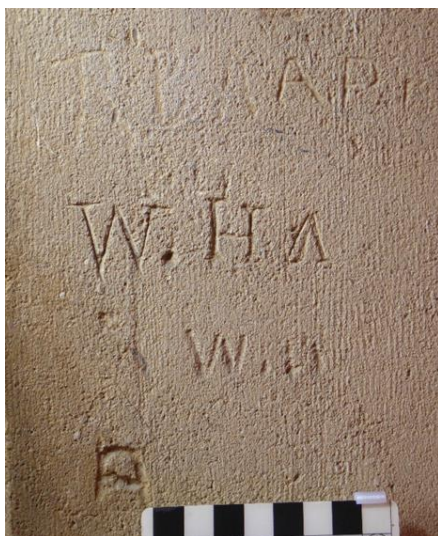
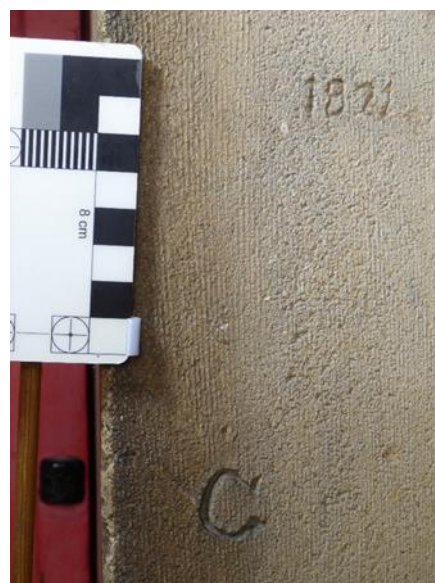
*Figs 28 & 29. South porch. Initials*

On the west jamb of the inner doorway into the church are incised single and pairs of initials, including AP and WH (Fig 28), with the date 1821 and a single initial C (Fig 29) on the east jamb.

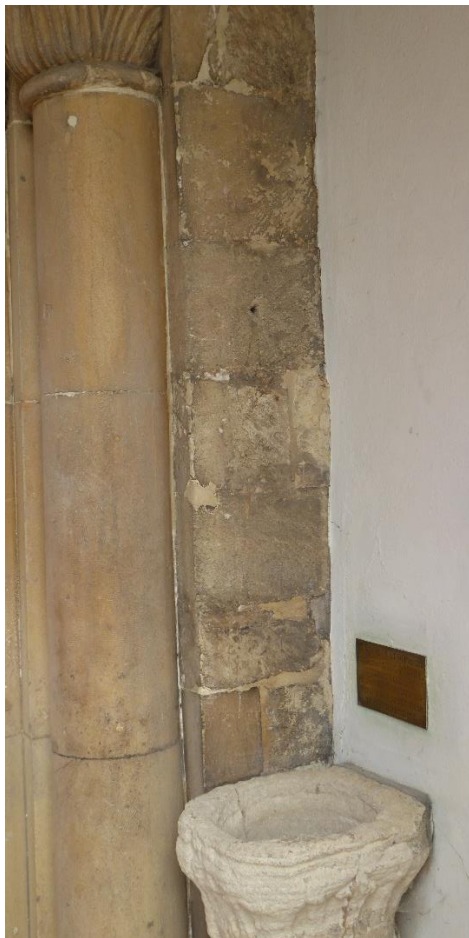
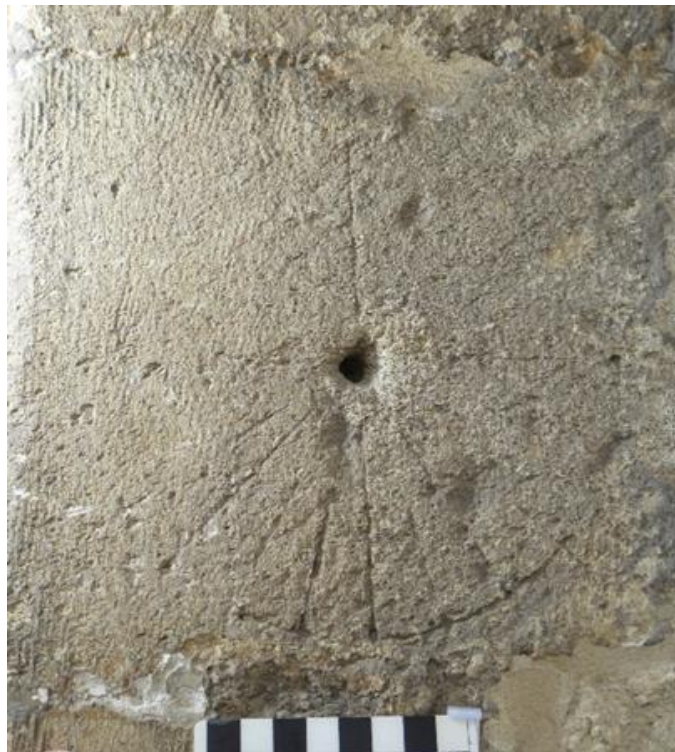
On the wall to the east of the door is a scratch or mass dial (Figs 30 & 31). A central stick or gnomon would have been placed in the central hole and cast a shadow onto the diagonal lines radiating from the hole, to mark the times of the daily church services. Inside the porch, below the mass dial, is a holy water stoup, originally from Hyde Abbey.

*Figs 30 & 31. South porch. Mass dial on wall to east of doorway*

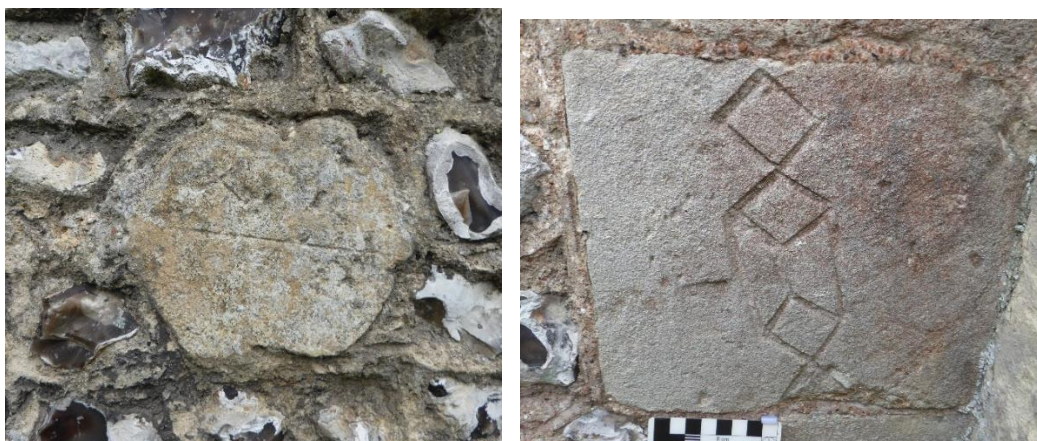
Within the church fabric are many reused stones from the Abbey, which was dissolved in 1539. These have been recorded elsewhere, and are outside of the remit of this report, but worthy of note here is a circular stone from a column, which has a mason's marking out line clearly visible on it (Fig 32). Another block, near to

the west doorway leading into the north aisle, has unusual geometric shapes carved into it (Fig 33).

*Figs 32 & 33. Reused stones from abbey built into church fabric*
