Winchester Cathedral.  
Reparation of the Nave Roof.  
1896 and 1897.

## THE NAVE ROOF, WINCHESTER CATHEDRAL.

WITH AN ACCOUNT OF THE WORKS OF REPARATION, EXECUTED  
DURING 1896.

By J. B. COLSON, F.R.I.B.A.

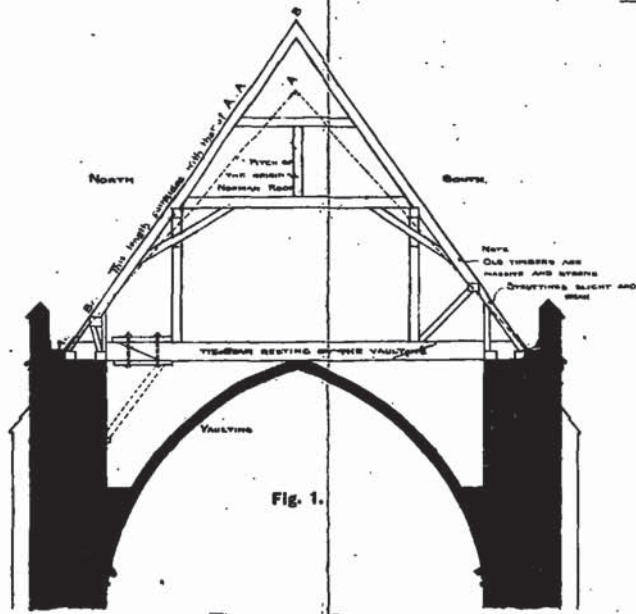
Fig. 1.

— TRANSVERSE SECTION —  
— PRIOR TO REPARATION —

In the accompanying drawings, the transverse section, Fig. I.; shews the construction of the roof prior to reparation as it is believed to have been left by William, of Wykeham.

Considerable mystery was attached to the fact of the old rafters being supported upon plates or cills, raised off the walls (Fig. I). It was surmised that the feet of the rafters having become defective, they were cut off, and this method of support was adopted instead of renewing the whole rafter or splicing the ends of the timbers in order to obtain the required length. It must be borne in mind that before the commencement of the recent work the "pitch" of the roof as originally constructed by the Normans was also believed to have been retained by Wykeham, and that he only re-framed and strengthened the timbers renewing where decayed, and supporting them on the tie beams and vaulting as shown in the illustration. From the general Norman character of the structure, there was foundation for such belief; but at the outset of the work when timbers were removed, and a closer examination could be made, the opinion that had prevailed was proved to be fallacious, for on the face of the tower was found the projecting string course indicating the Norman roof to have been of a much flatter pitch, and thus dissipated the idea of Wykeham having retained the "lines" of the Norman structure. This led to a more complete investigation, and on measurement it was found that the length of the Norman rafter exactly coincided with the rafter on the north side of Wykeham's roof. From this fact, and the old timber showing signs of previous framing, we are led to conclude that Wykeham re-constructed the roof, using the original Norman rafters and timbers as far as they were serviceable, thus retaining the general Norman appearance of the structure. The increased "pitch" in conformity with that of Edington's gable at the west end being obtained by raising the rafter feet off the walls and supporting them as alluded to.

It will be noticed that the position of the cill-piece or plate upon which the rafters on the south side rest, differs from that on the north side, being at another level; the rafters being less in length and the cill consequently higher. This may be accounted for by the reasonable supposition that in re-

It was to this arrangement of various lengths of rafters with cills or plates at different levels, and no direct ties at the rafter feet, that the disintegration of the roof timbers may be attributed. The weakness was realized and an attempt to frustrate evil effects was made by the insertion of longitudinal timbers or purlins under the collars and the uprights or queen posts, supported by the main tie beams which extended from wall plate to wall plate on either side. The upper part of the structure was thus as it were carried on crutches, the whole of the weights was thrown on the tie beams instead of on the walls. Had the tie beams been sound the attempted remedy would probably have been effectual, but the tie beams themselves were scarfed, in some instances with joints at both ends, and were supported in the centre by the crown of the nave vaulting. The scarfing was rudely executed and soon the beams became displaced thus causing a movement of the whole structure and a settling down of the same on the tie beams and vaulting.

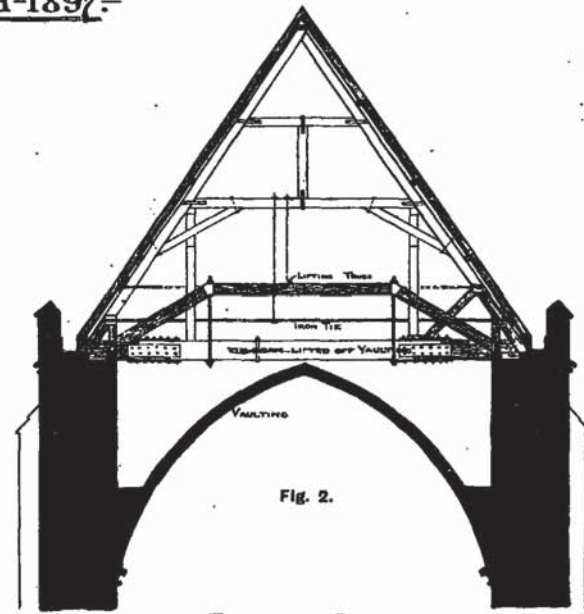
Fig. 2.

— TRANSVERSE SECTION —  
— SHewing METHOD OF REPARATION —

Fig. II. illustrates the method of reparation. The new timbers and construction are denoted by being "hatched," and the old work left in outline only.

The section (Fig. II.) in the illustration shows the method adopted of strengthening the beams and enabling them to carry the weight imposed upon them. Lifting trusses have been formed on each side of the tie-beams, the beams have

been raised and the vaulting thus relieved of the enormous pressure. In strengthening the tie-beams it was found necessary to renew three of them, and owing to the difficulty in obtaining English oak of sufficient length and size, it was found necessary to resort to the use of oak from Stettin. All other timbers found defective have been removed and replaced with the same material.

A false cill piece has been inserted at the back of the rafters on the north side at a corresponding level to that of the cill on the south side and these cills have been securely tied together from north to south with stout iron bolts.
