St Nicholas church, Bishop's Sutton

Historical graffiti survey report

27th May 2023

Hampshire Medieval Graffiti Project

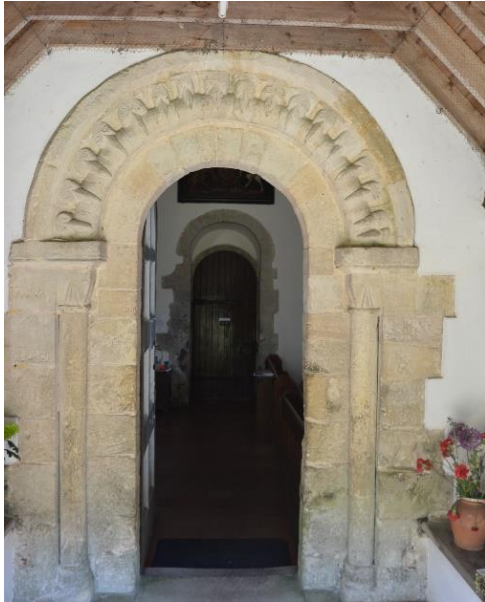
The church was built in the 12th century as a simple two bay structure of nave and chancel by the Bishop of Winchester, Henry de Blois. From this period date the fine south doorway with its characterful beakheads (Fig 1), and the wide chancel arch.

1 The south doorway with beakheads

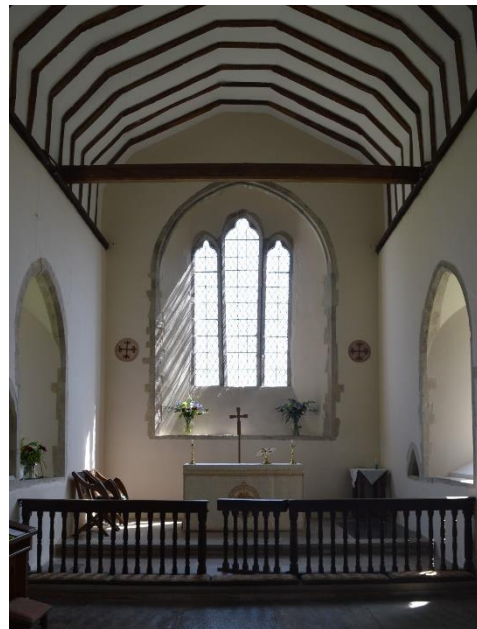
The church was later added to, and parts rebuilt. The chancel is of the early 13th century and has two surviving consecration crosses painted on each side of the east window (Fig 2).

2 The east end with consecration crosses

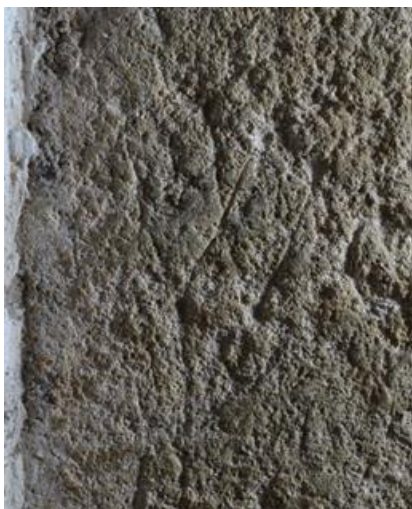
On the west side of the doorway is one faint possible devotional mark, a pair of intersecting Vs forming a W shape, which could be a symbol for the Virgin Mary, VV standing for Virgo Virginum, Virgin of the Virgins (Fig 3). Most of the graffiti here consists of pairs of initials, sometimes boxed, and sometimes with dates. This type of graffiti dates from the seventeenth century onwards, when literacy was more widespread and people could write their names. The accompanying dates include examples from the seventeenth and eighteenth centuries (Figs 4 & 5).

3 South doorway, west side. Intersecting Vs, possible devotional mark for the Virgin Mary

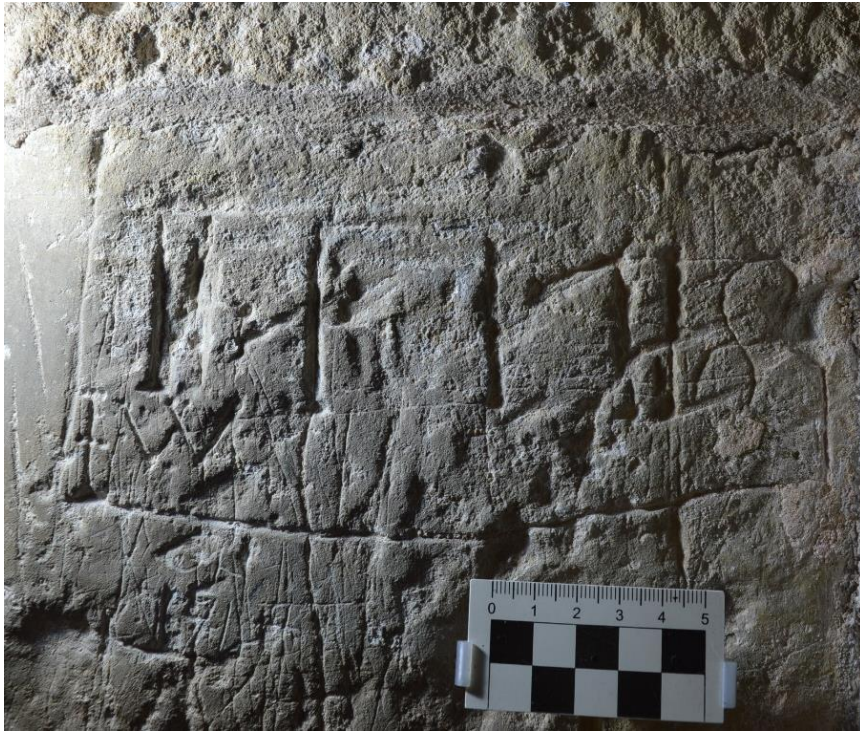
4 South doorway, east side. Boxed initials dated 1718 and initials IW

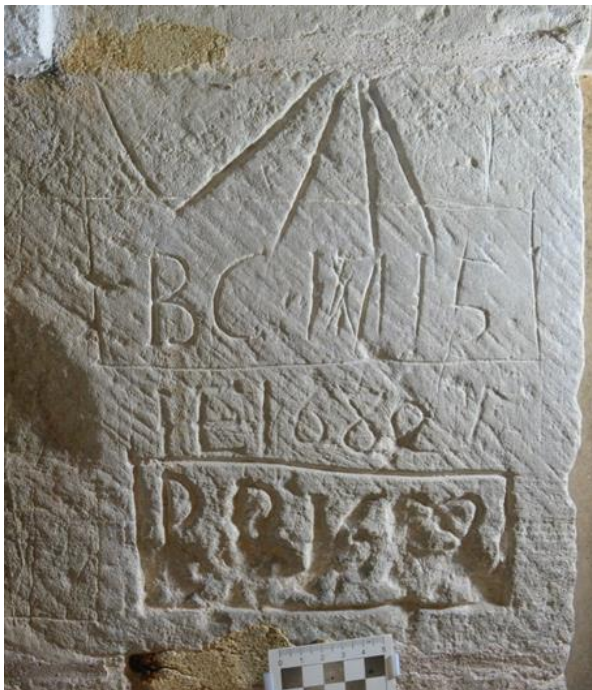
5 South doorway, west side. Boxed sets of initials from the 1600s and 1700s. Scratch dial at top of block

Above the group of initials on the west side of the doorway, shown in Fig 5, are radiating lines which are probably a scratch or mass dial. A stick inserted in a central hole at the top would have served as a gnomon, casting a shadow to show the hour of the day when particular religious offices would be carried out by the priest. These dials were usually next to the church entrance. Another dial can be found on a reused stone block on the exterior of the building. (Fig 14). These dials were recorded by Green (1943) although he refers to 2 dials being on the west jamb of the south doorway.

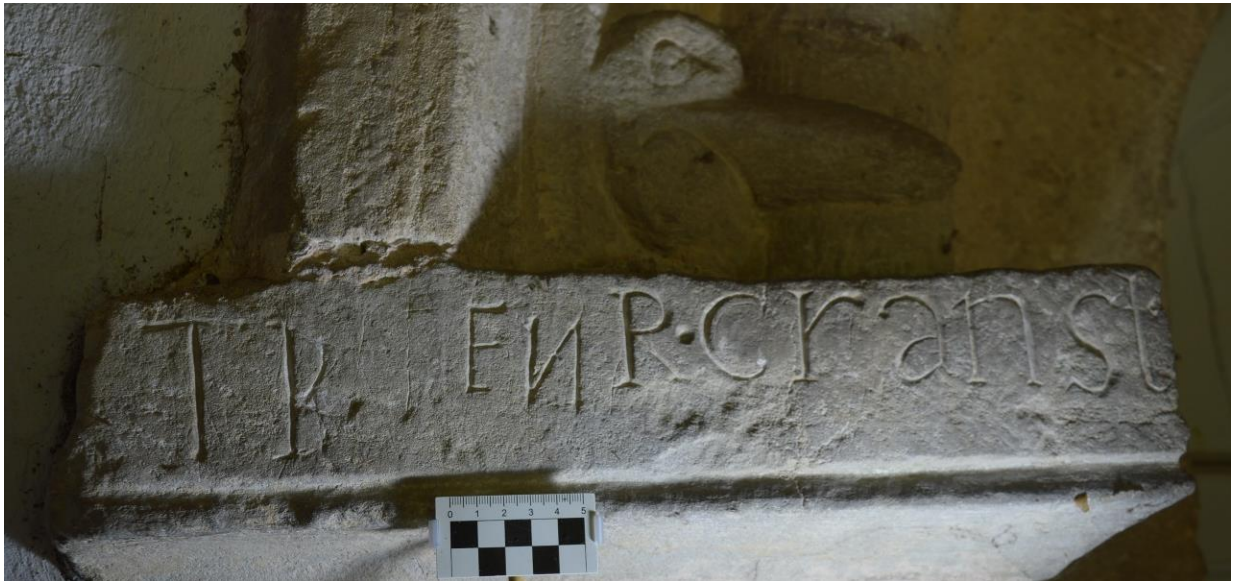
Most notable is the finely carved name and date R. Cranston 1752, engraved within the porch on the west side of the south doorway, on the impost over the column and continuing onto the door surround and jamb (Figs 6 & 7).

6 South doorway, impost above west column capital. Beginning of R. Cranston inscription. Other initials TB, EN

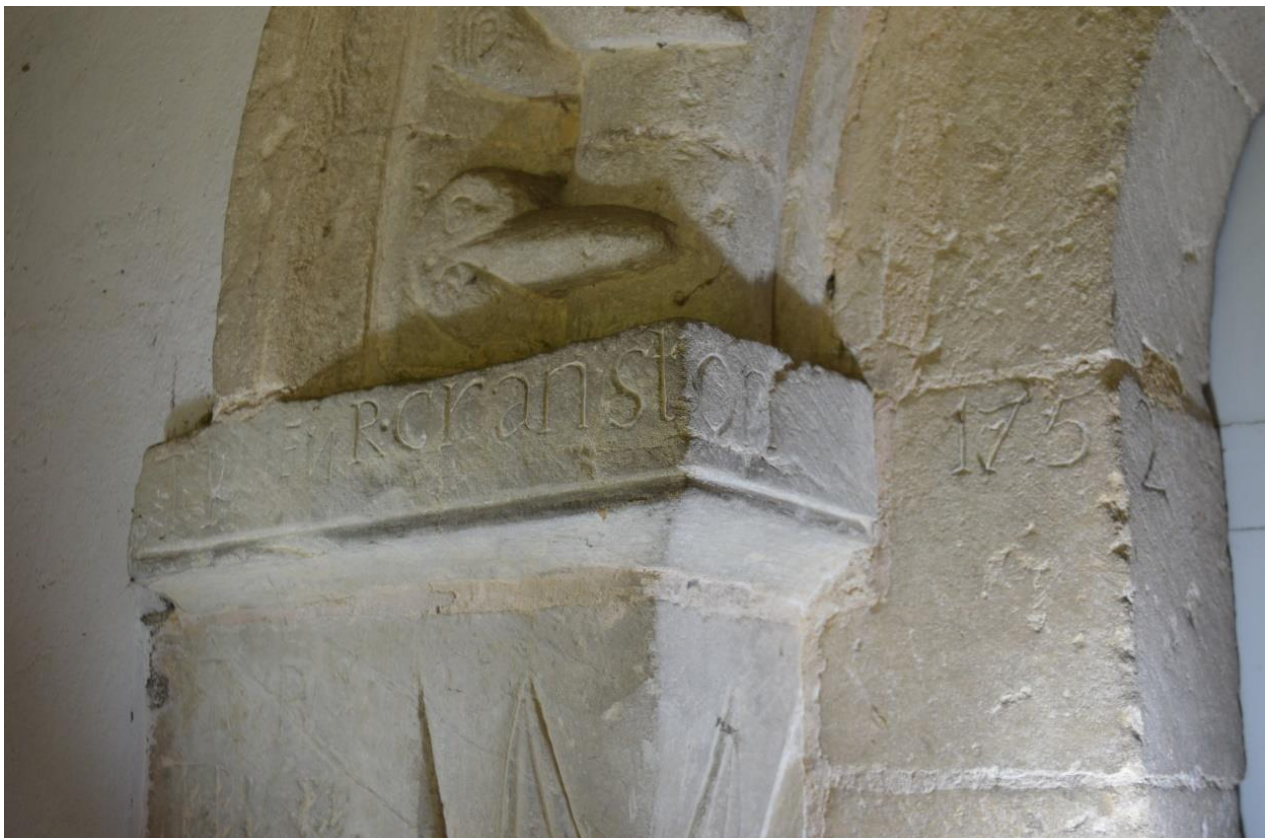
7 South doorway, west side. R. Cranston 1752 inscription running around impost onto arch

I am indebted to my colleague, Helen Banham, for drawing my attention to the book *Ropley's Legacy* by Chris Heal, which mentions Robert Cranston, labourer, of Bishop's Sutton who, in 1744 undertook a perambulation around Bishop's Sutton seeking to prove his right to two small areas of land.

It would seem fair to assume that this is the same person, and that 1752 could be the date Cranston settled his claim. He could have recorded his name on the church fabric to add legitimacy to this claim. Church porches were often used for the transaction of local business and the payment of debt, which would add weight to this theory. It could also explain the presence of so many other sets of dated initials from this time.

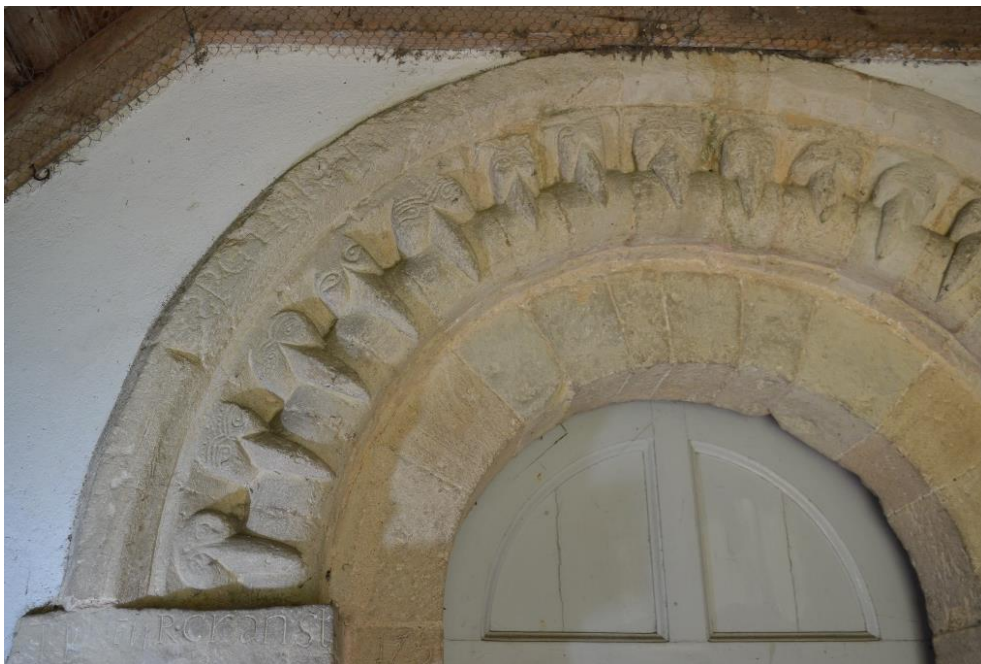
Above the beakheads the traces of a faint inscription can be seen on the west side of the arch (Fig 8).

8 *Traces of inscription on arch above beakheads*

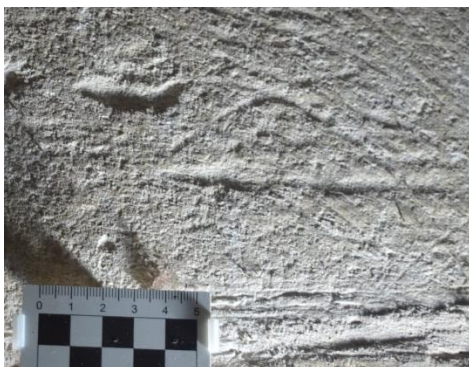
Also in the porch, to the west of the doorway on the outer face, is a semicircular mark which could be a mason's mark (Fig 9). No other examples of masons' marks were found during the survey.

9 *South doorway, west side. Possible mason's mark*

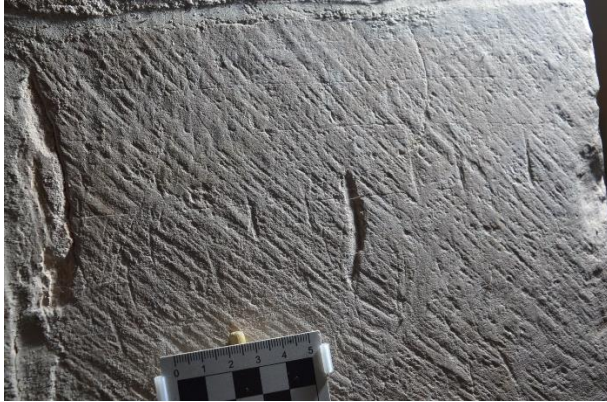
Within the **nave**, there is graffiti on the east and west jambs of the north doorway. This includes sets of parallel lines, some of which could possibly be music staves, as one area has marks superimposed which could represent musical notation (Fig 10).

10 Nave, north doorway, possible musical notation

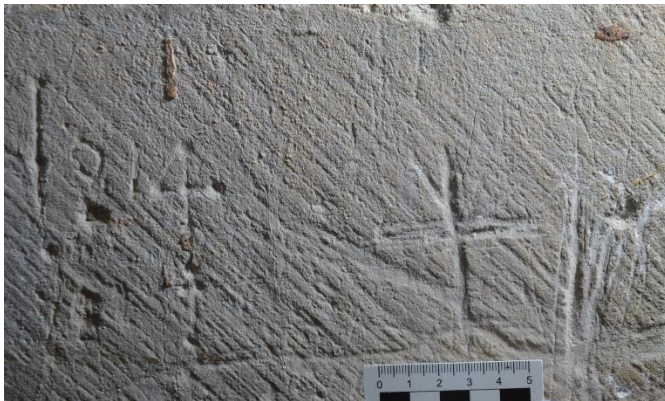
On the north jamb of the **chancel arch** the graffiti includes several crosses, one of which has dots at the terminals and lines joined to form a triangle at the top (Fig 11).

11 Chancel arch, north jamb, crosses

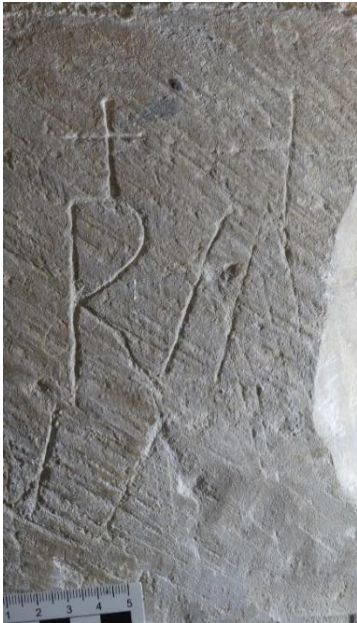
Nearby are two crosses adjacent to the initials RM (Fig 12). The presence of these crosses in a particular area could indicate that this was a site of a pre-Reformation altar.

12 Chancel arch, north jamb, initials RM and 2 crosses

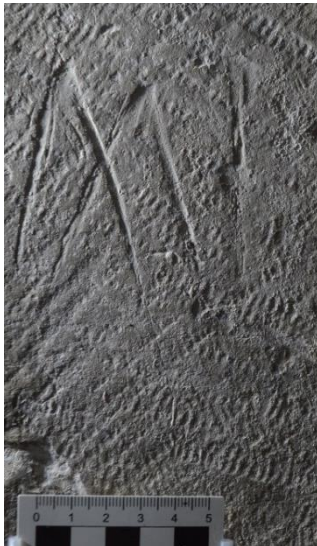
On the east jamb of the **south door** is a mark made of 2 inverted intersecting Vs which could be the initial M, as in the initials RM noted above, or possibly a so-called Marian mark, incised as symbol of devotion to the Virgin Mary (Fig 13).

13 Chancel, south door, east jamb, initial M or Marian mark?

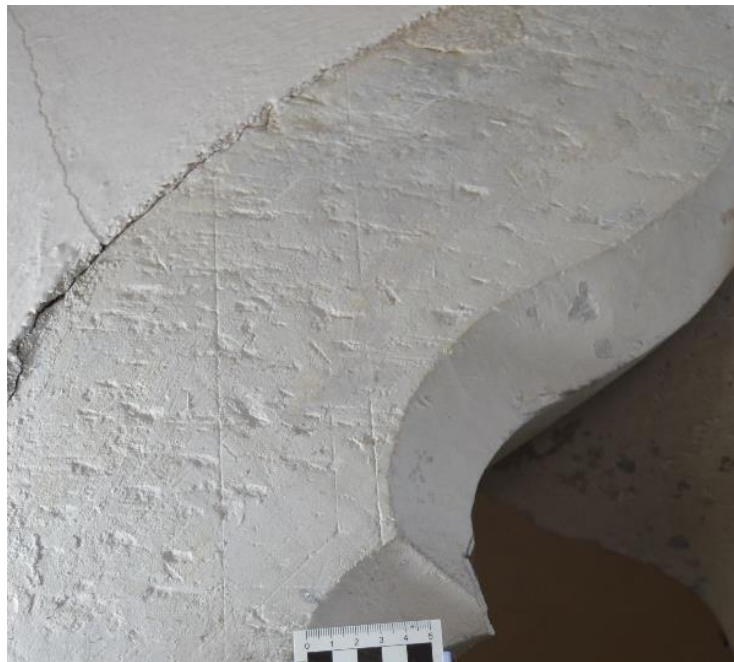
A small cross is incised within the **squint**, on the north side of the chancel, and fine marking out lines made by masons are visible around the decorative opening (Fig 14).

14 Chancel, squint, marking out lines

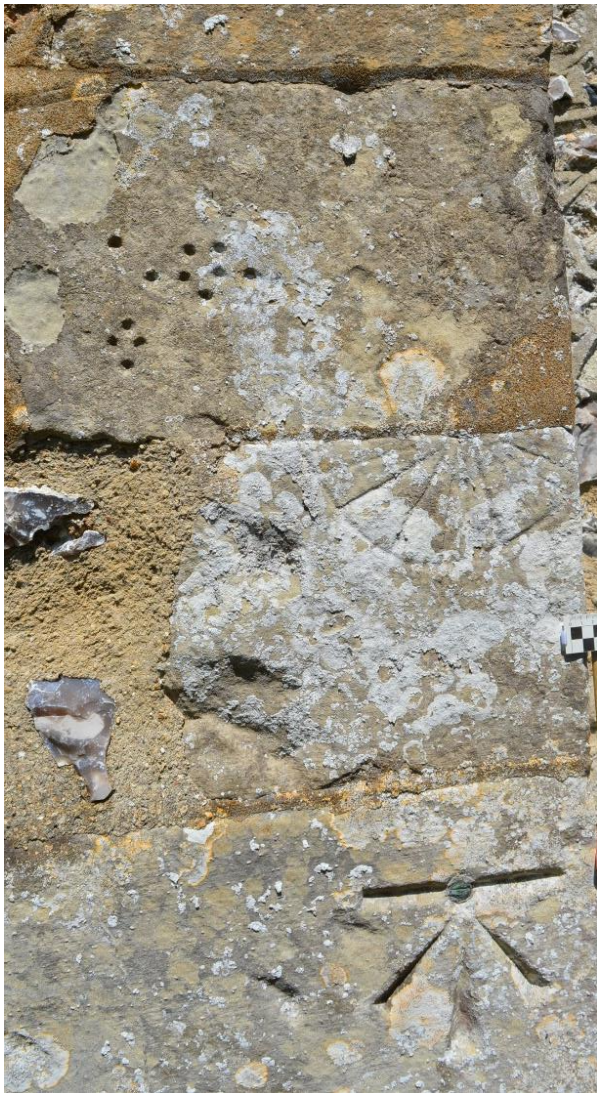
On the angle between the nave and chancel on the south side three different types of marks can be seen, on blocks of stone one above the other (Fig 15).

15 South face, angle between nave and chancel, dot patterns, scratch dial and Ordnance Survey benchmark

At the top a group of dots have been drilled. The purpose of these is not known, although it is sometimes suggested that these are areas where stone has been scraped away to be used in folk remedies and potions, a tradition that is known to have occurred in holy places and shrines all over Christian Europe (James Wright, 2021). Dots were also used as guides for the carving of shapes such as crosses, as that shown in Fig 11.

Below the dots is another scratch or mass dial, with lines radiating beneath a central hole. As these dials were usually next to the church entrance, this block has probably been moved and reused.

Beneath this is an Ordnance Survey benchmark. Although not graffiti, this mark is of historical interest and can be seen marked on the Six-Inch Ordnance Survey map of 1872, as BM 276.5 (Fig 17).

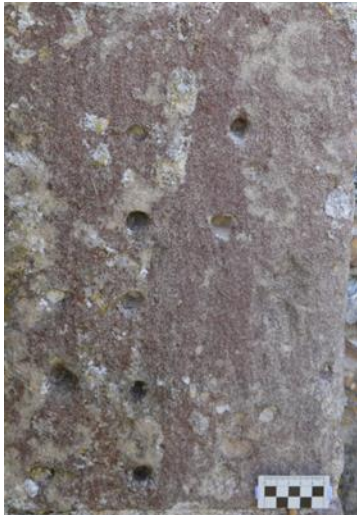
16 Chancel exterior, northeast corner, dots

Another group of more regularly spaced dots is on a block on the northeast corner of the chancel (Fig 16).

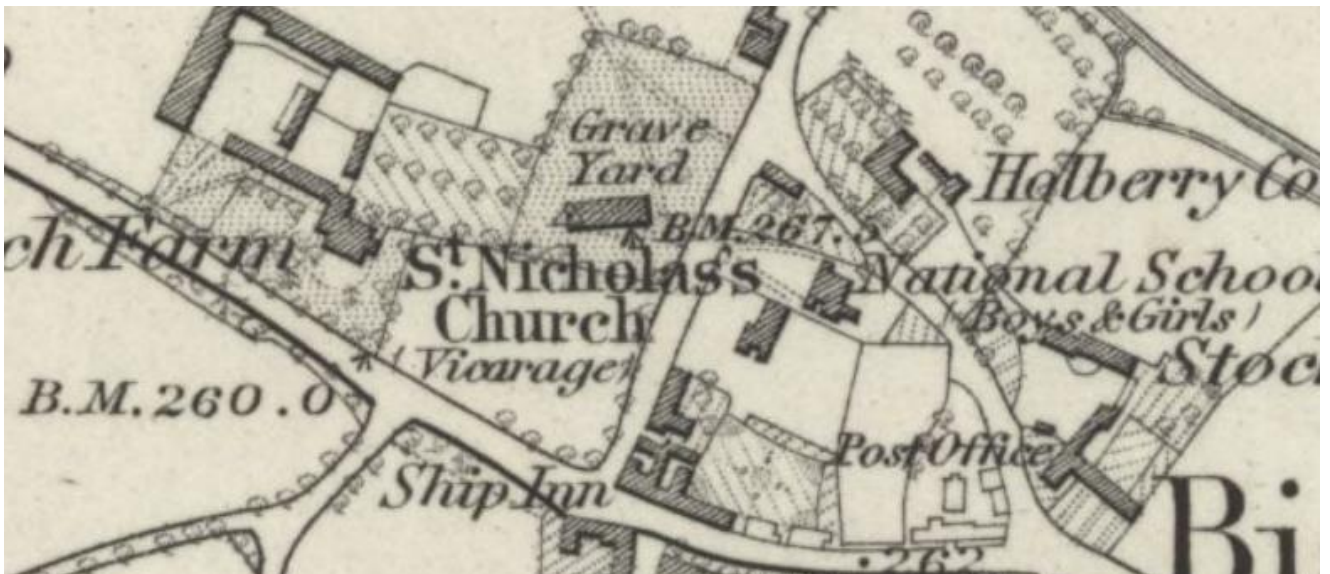
17 Six-Inch Ordnance Survey map of 1872, arrow showing location of benchmark on church
