THE EXCAVATION, RECOVERY AND ANALYSIS OF AN EARLY 19TH-CENTURY SHIPWRECK FROM THE SOLENT, HAMPSHIRE

By STEPHANIE SAID *and* EUAN McNEILL

ABSTRACT

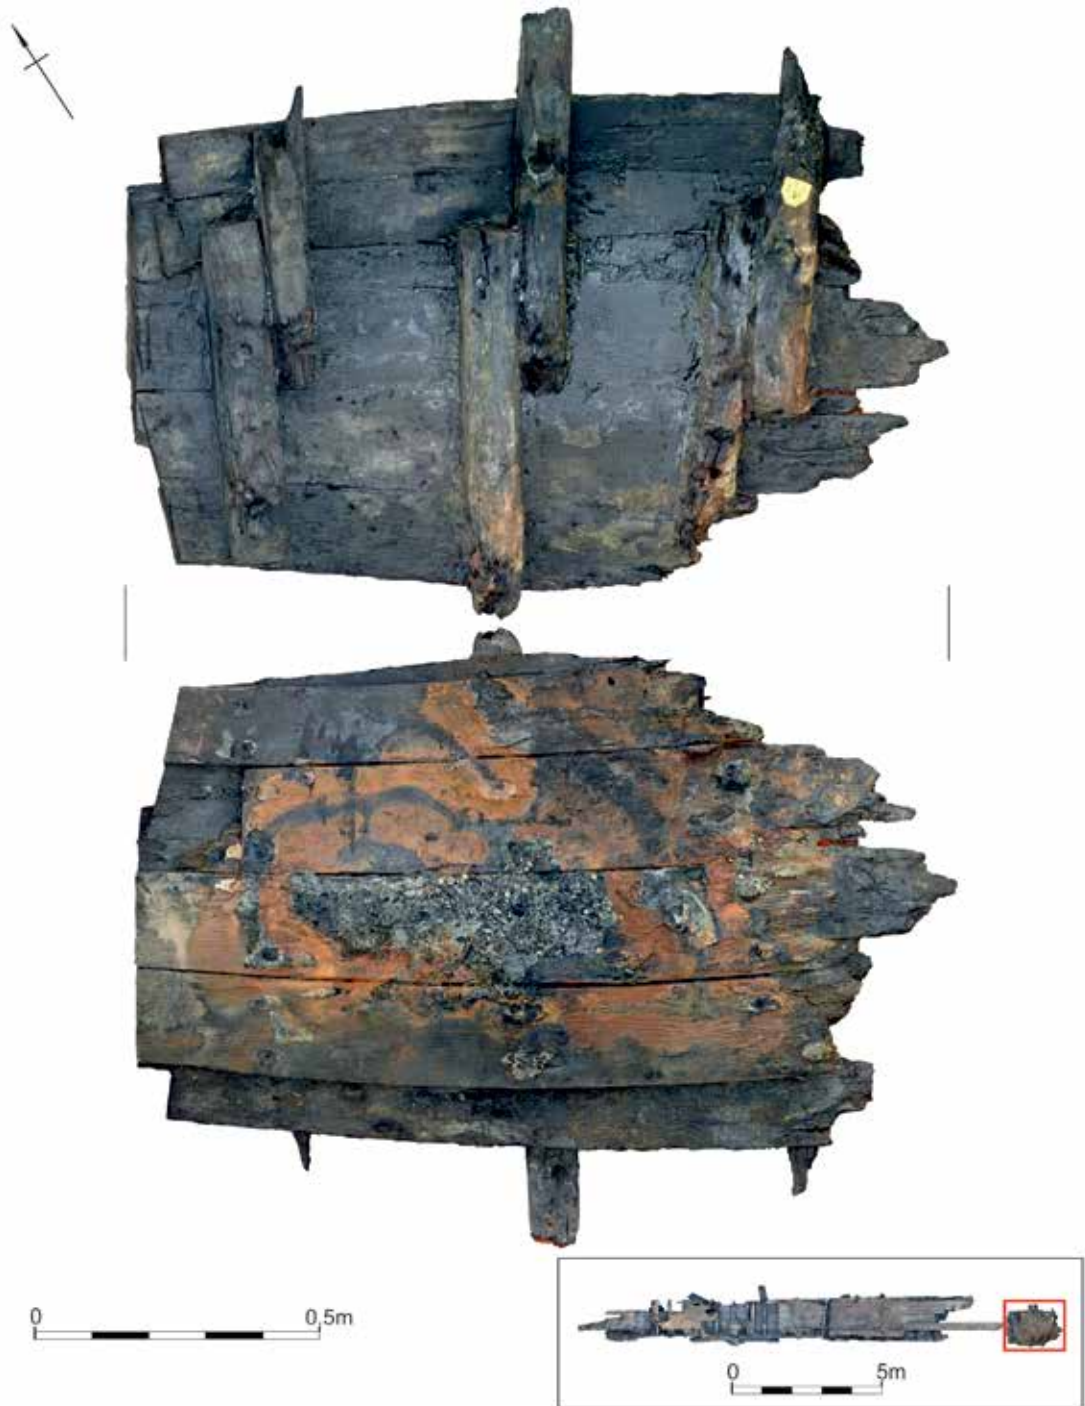
Fig. 3 Photogrammetric model of extant inboard and outboard forepart (WA5077) of shipwreck

The forward end of the wreck (WA5077) preserved the remains of six framing elements (probably futtocks), six inner planks and four outer planks, all preserved *in situ* (Fig. 3). WA5077 had a width of 1.00m and a length of 1.45m. This section was covered over by the concreted chain, which was removed to expose the frames. No ceiling planking was preserved, and no evidence to suggest any existed within this section, with all visible treenails sitting flush on the frames. Treenails with an average diameter of 28mm were noted fastening outer planking onto framing elements. Square shafted iron nail holes were observed along rebates of the inner planking, measuring 100 × 50mm, and along the upper and lower edges of

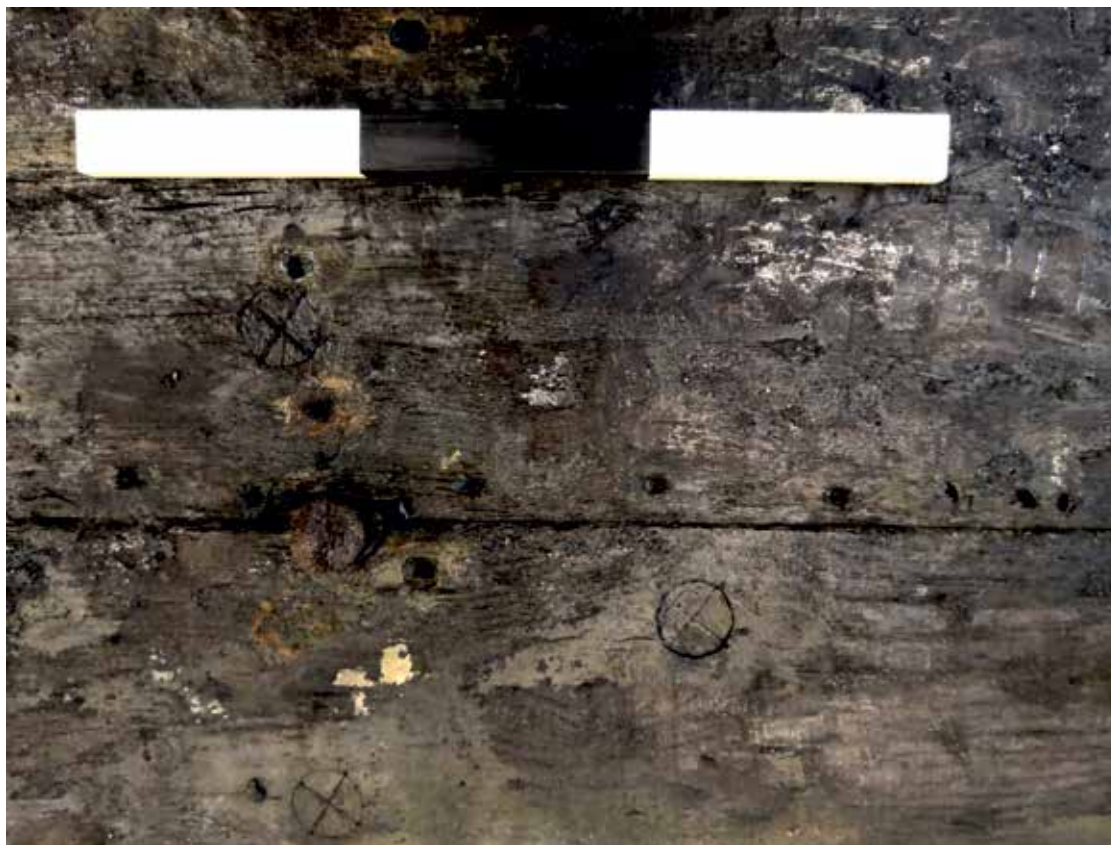
Fig. 5 Detail of wedged treenails and square shafted iron nail holes

approximately 300mm long and 150mm thick, filling out the spaces between double and single frames. As with Section WA5077, treenails, measuring 28mm in diameter were utilised to fasten framing elements to inner planks and to attach outer planks to inner planks onto frames. Wedged treenails (with x mark's) were often observed aligned with the framing elements, however, no specific pattern was noted (Fig. 5). Square shafted iron nail holes have been observed along rebates of inner planking and along the upper and lower edges of outer planks (Fig. 5).

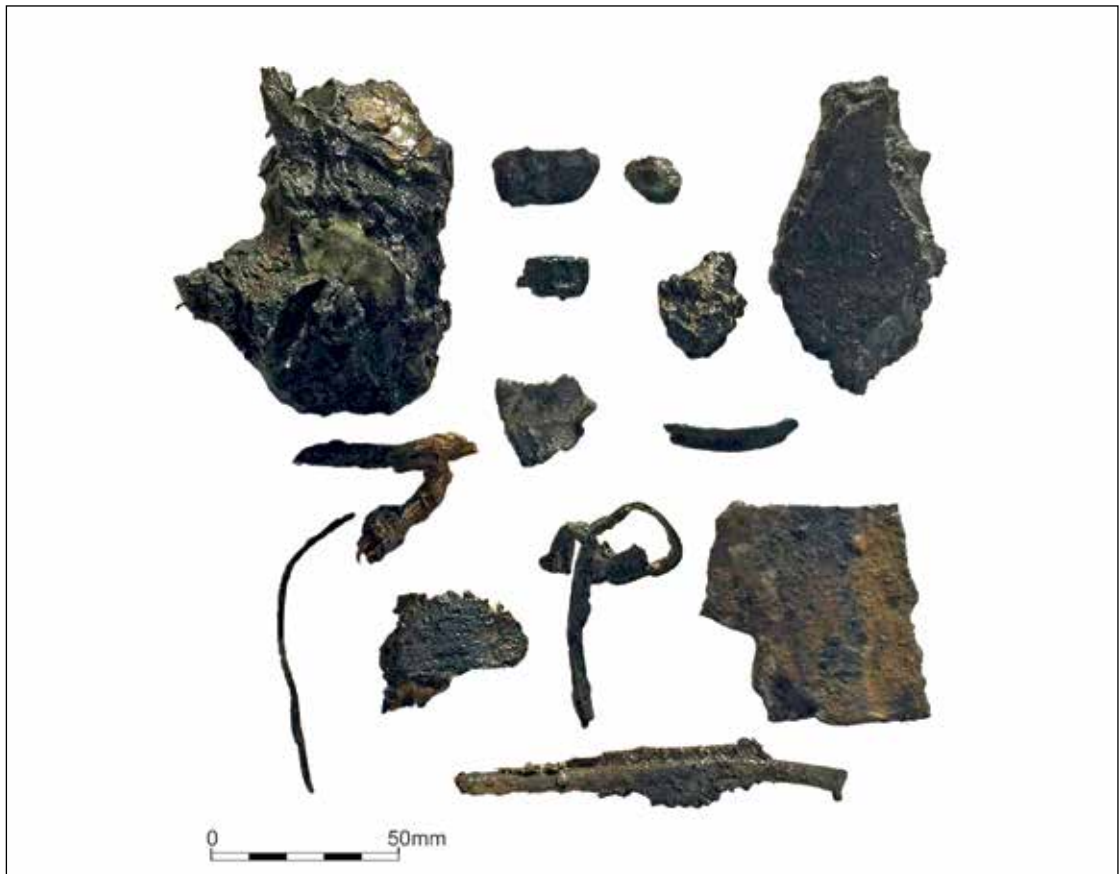
Fig. 7 Possible oil lamp

Sample WA5077 had a mass of concreted chain overlaying it with hemp rope fragments, a heavily corroded iron shackle and the remains of what is believed to be a metal container, an oil lamp (Fig. 7), and its saponified oil, buried

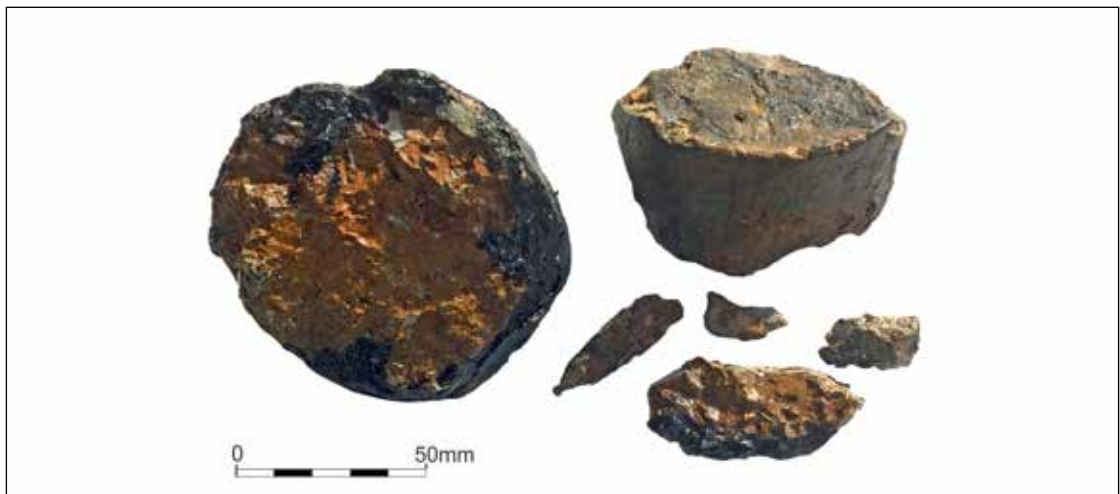
Fig. 8 Saponified oil from lamp preserved in concretion

within the concretion (Fig. 8). Also recovered from this area were the remains of what appears to be a metal rowlock and bar. Two stones laying within the wreck were also recovered by the divers as potential ballast stones. No further metallurgical analysis was recommended on the sampled chain, as these were associated with chain cable generally found on 19th-century vessels.

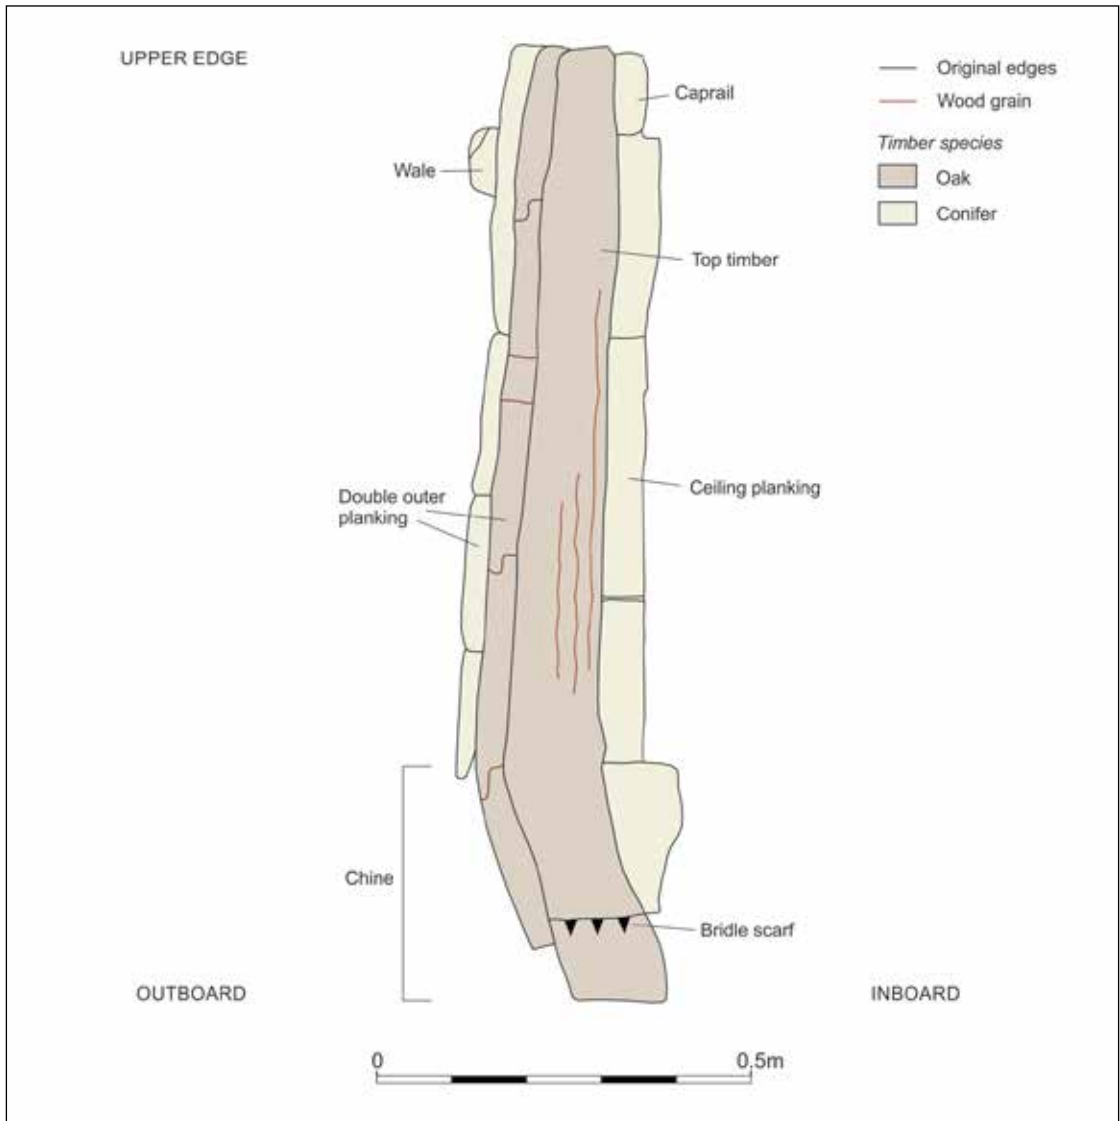
Fig. 9 Section plan of WA5074, showing bridle scarf located at the timber heel, wale, and double outer planking

The method of assembling frames by means of bridle scarfs is prominent in the shipbuilding of barges along the south-east coast of England and within the Thames Estuary (Benham & Finch 1983). During the deconstruction of the three sections, no corresponding fastening holes were observed on the bridle joints where the floor timbers would have been slotted on. No pattern could be conclusively determined with regards to location of frames with bridle joints, whether these were paired or found as single frames, or whether they were located at specific intervals. Section WA5076 exhibits two top timbers which are paired timbers that do not retain a bridle joint but end flush towards the timber heel (Fig. 10). Most timber heads ended with a lap joint where the caprail would have fitted on.

The double planking preserved in the wreck consists of an inner rebated oak plank layer measuring 1.5 inches (3.81cm) thick, and an outer layer of flush-laid pine or elm planking measuring 1.2 inches (3.048cm) thick (Fig. 12). Although the method of oak planking is the same as described above, the dimensions vary
