# St Bartholomew's Church, Hyde, Winchester

## Historical graffiti survey report

Date of survey: **17<sup>th</sup> October 2025**

**Hampshire Medieval Graffiti Project**

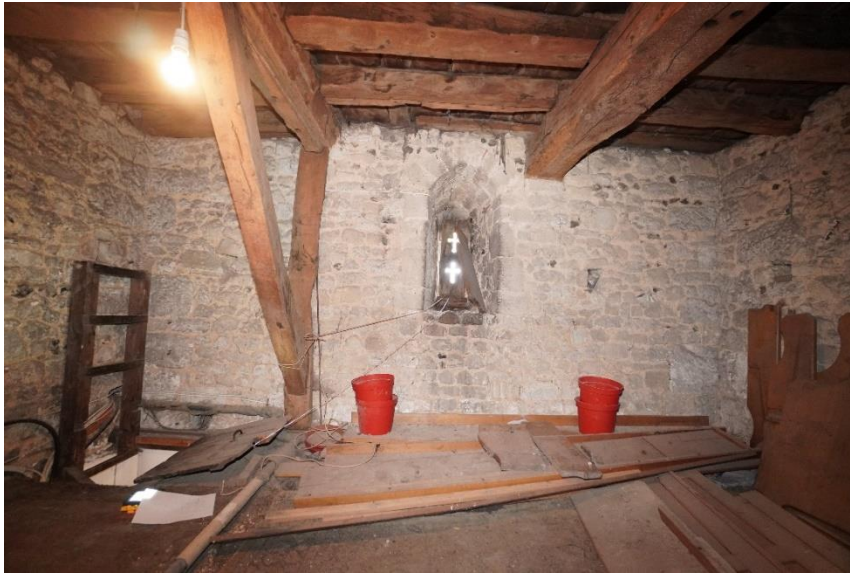
*Fig 1. Church tower. Second floor*

Many names and initials, some dated, occur as graffiti in the bell chamber and the floor below (the second floor), carved into the stone and woodwork. Carpenters' marks can be seen on the exposed timber framework on the first to third floors.

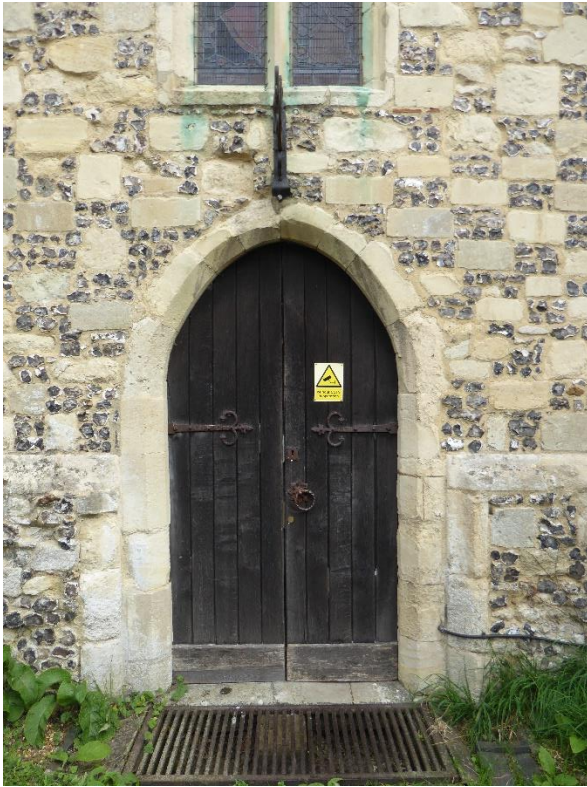
Fig 15. Tower. West doorway

The west doorway of the tower (Fig 15) has graffiti on both sides of the arch. There are matching dates at roughly the same height on each side. That on the north side is incomplete with only 176 remaining (Fig 16), but the full date 1763 can be seen opposite, associated with the initials IE (Fig 17). Above the date on the north side is a shape which might be an initial W, or it might be a VV symbol, of interlocking Vs. Such marks are apotropaic in function and derive from the Christian symbol of devotion to the Virgin Mary, the VV standing for *Virgo Virginum*, or Virgin of the Virgins. Post-Reformation, this symbol seems to have lost its religious connotations and became more of a lucky symbol. It is often found around windows and doorways of buildings, to prevent the ingress of evil spirits. A similar VV shape, now very faint, can be seen above the 1763 date on the south side. Below the date is a wavy line whose significance is unknown. There was probably a lot more graffiti in this area but

the stone surface is very weathered and much detail has been lost. An initial S can be seen further down, along with other fainter lines and initials (Fig 18).

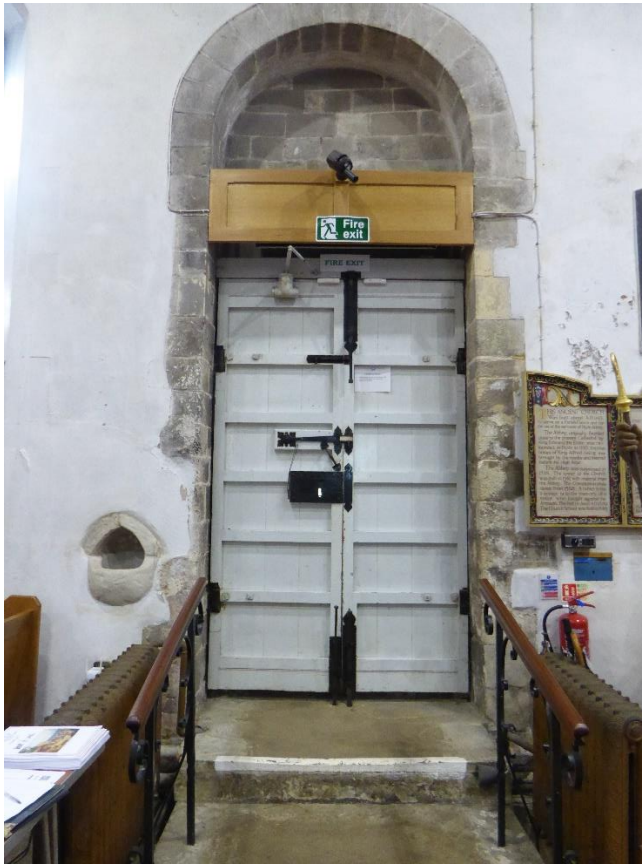
Fig 22. Nave. South doorway

The south doorway in the nave (Fig 22) has small crosses incised into the archway on the east side (Figs 23 & 24). Such crosses were probably made as a symbol of

personal devotion by parishioners entering or leaving the church and are a common form of graffiti found in churches.

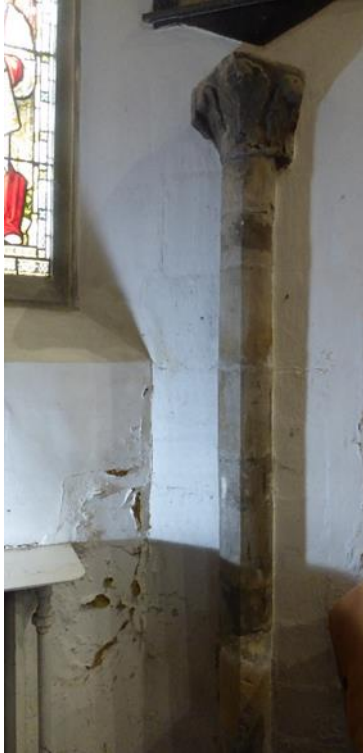
*Fig 25. Nave. South wall. Pilaster from Hyde Abbey*

On the south side of the nave, near the pulpit, a pilaster which came from Hyde Abbey is built into the wall (Fig 25).

On its east face are incised some faint lines which appear to have been made deliberately and may be figurative (Fig 26).

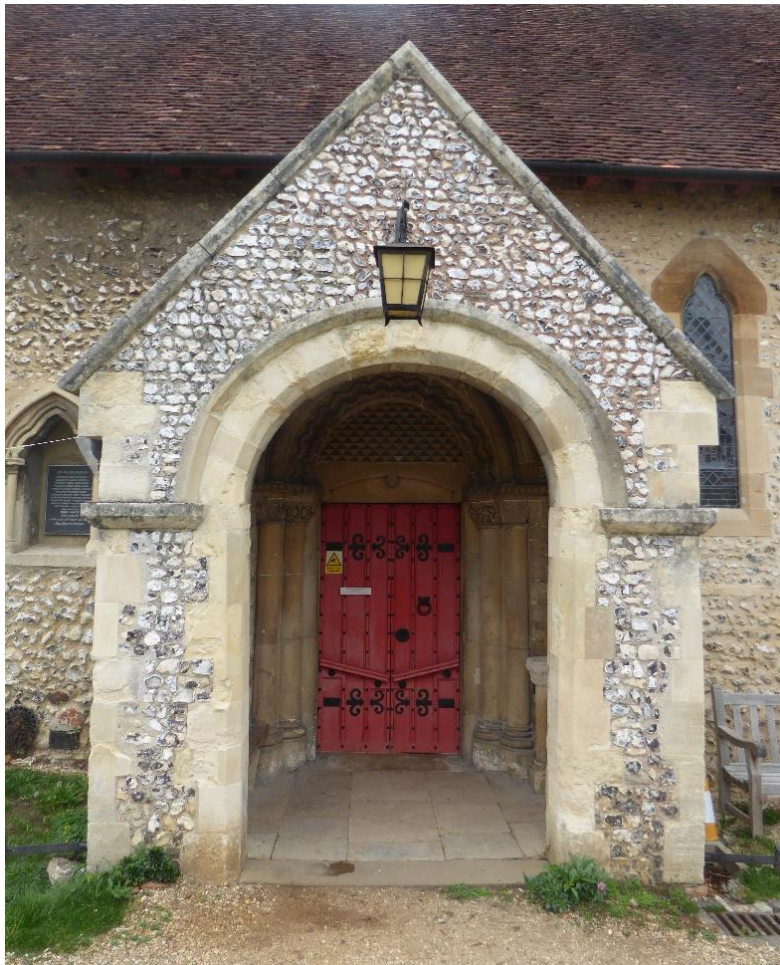
The south porch was built in the 19<sup>th</sup> century in front of the fine Norman doorway, which is dated to c1130. There is modern graffiti on the west wall of the porch, including lines and initials.
